# **Phase I Test Results**

## **Joint Test Protocol for Cadmium Alternatives for High Strength Steel**

Erin Beck

January 2006

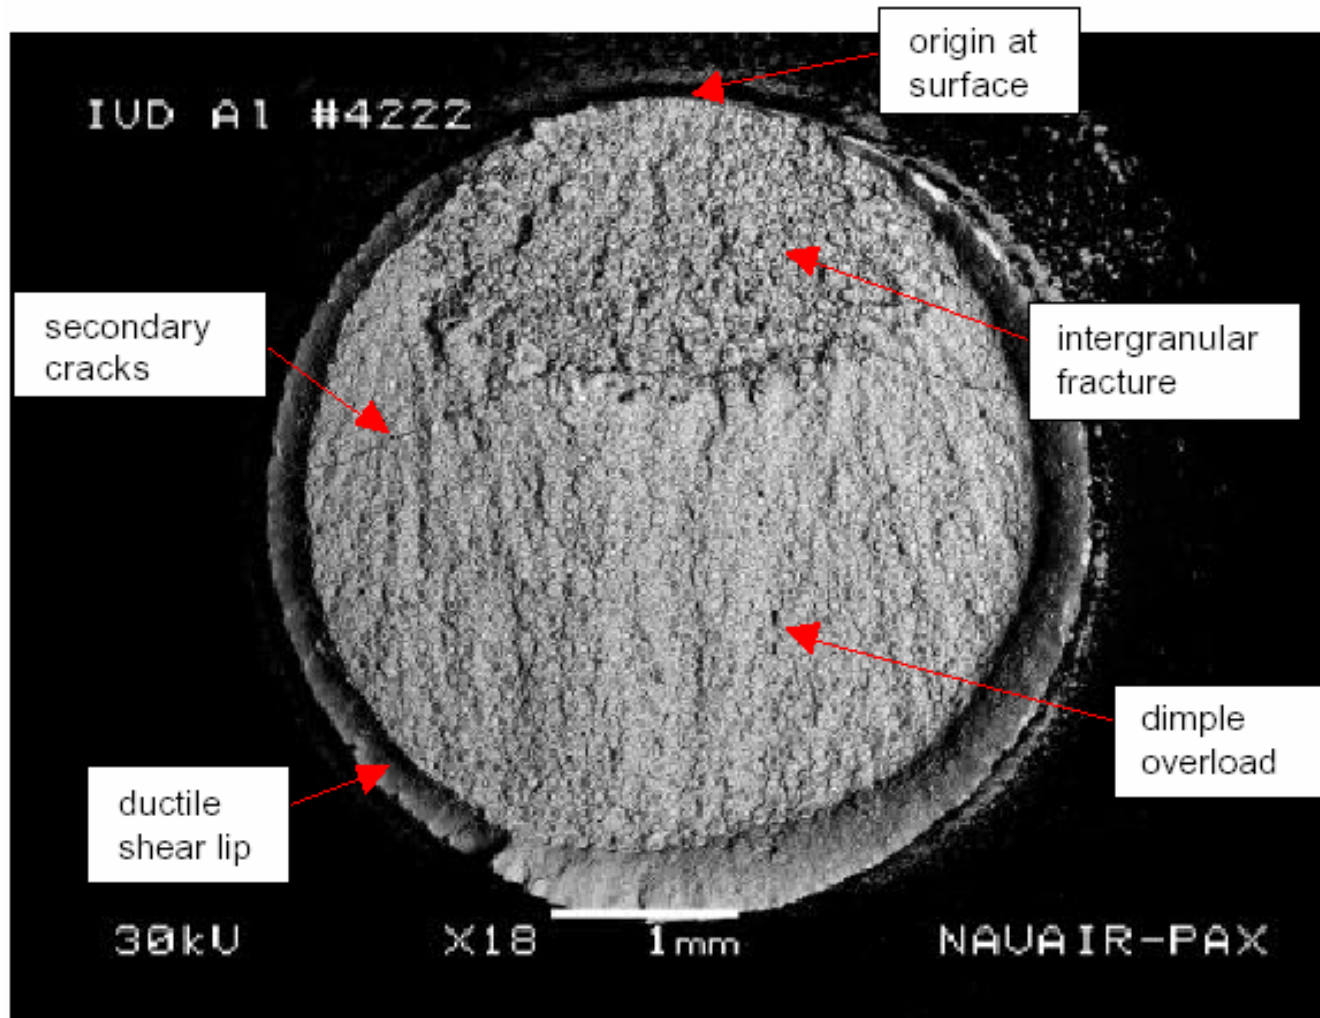
IVD A1 tested in DI water, failed at 45% NFS @ 18 hrs.

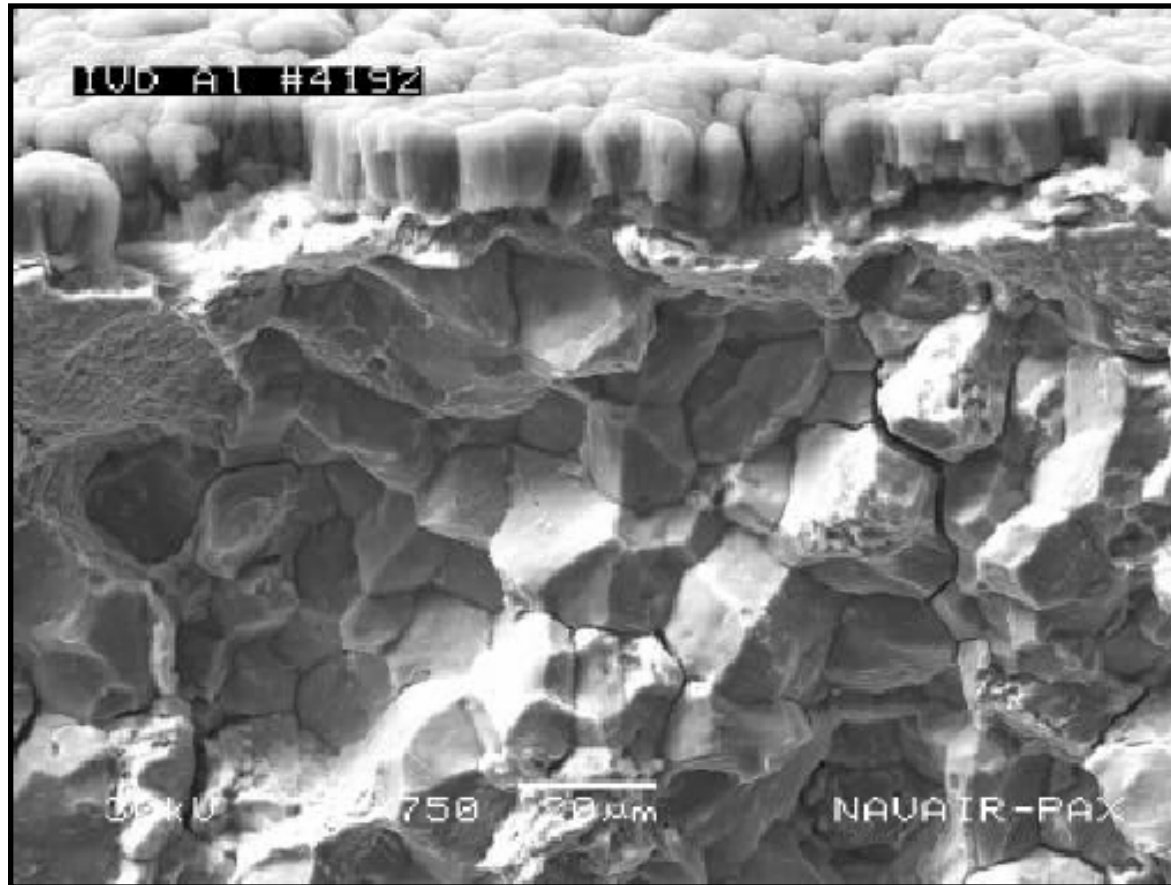
**Close-up of IVD Al tested in DI water.**

- Intergranular fracture, clear grain boundary separation.
- Coating appears at the top of the cross section.

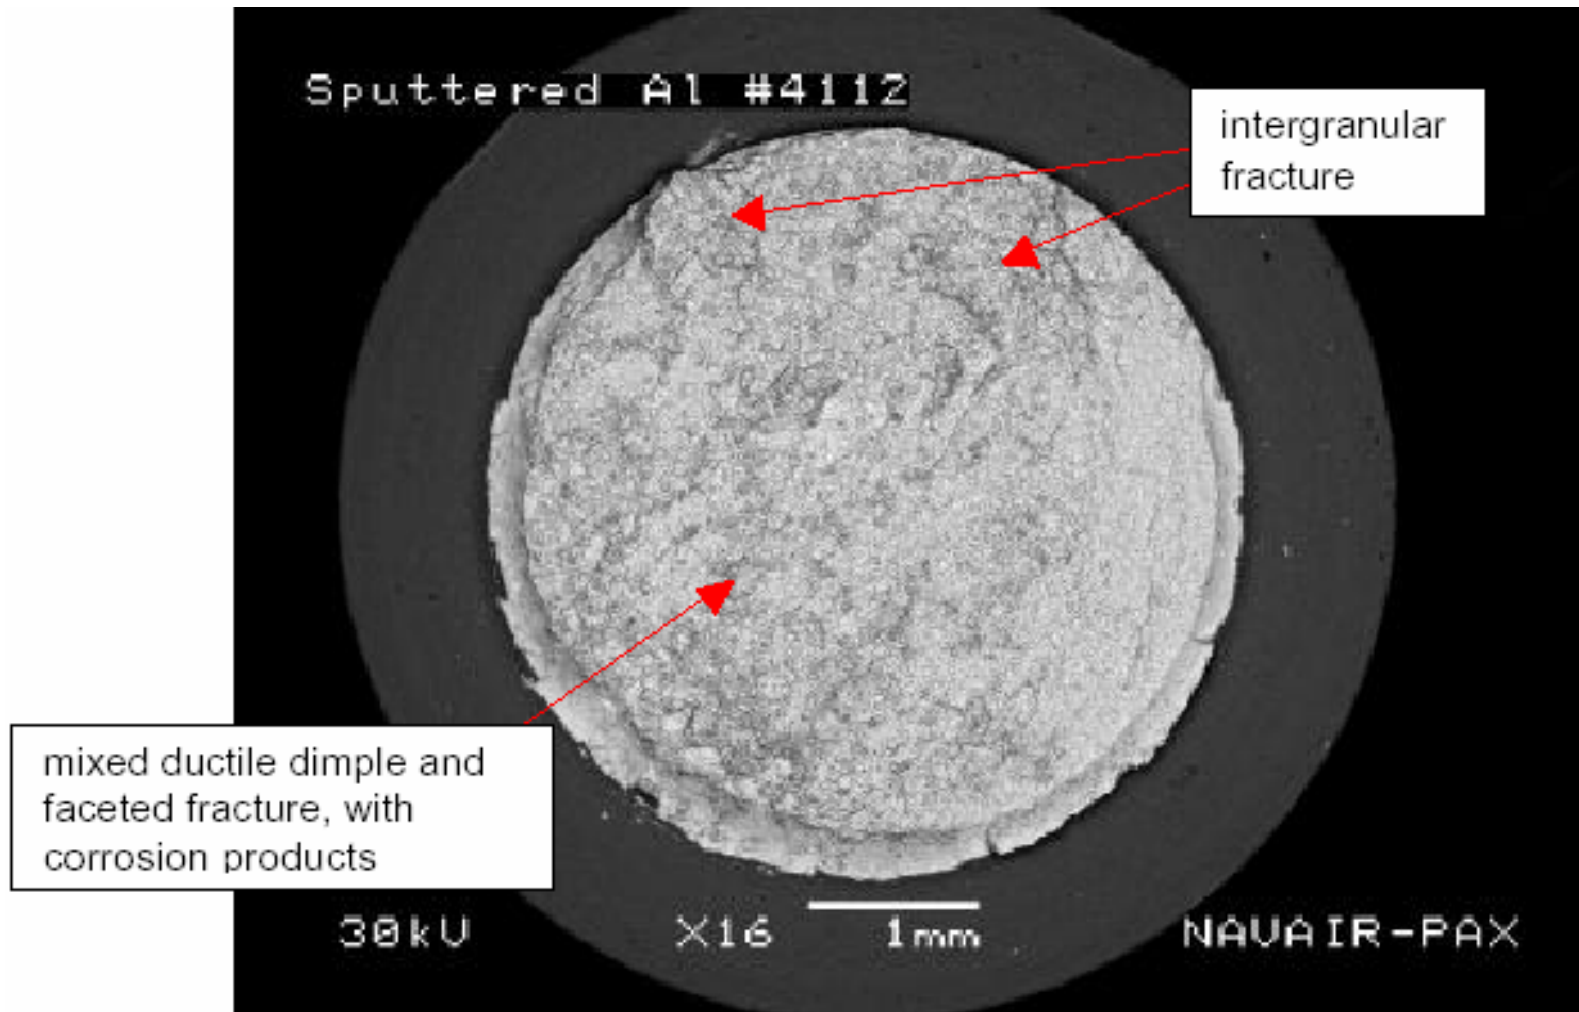
Sputtered Aluminum tested in seawater, failed at 55.5% NFS @ 25.7 hrs.

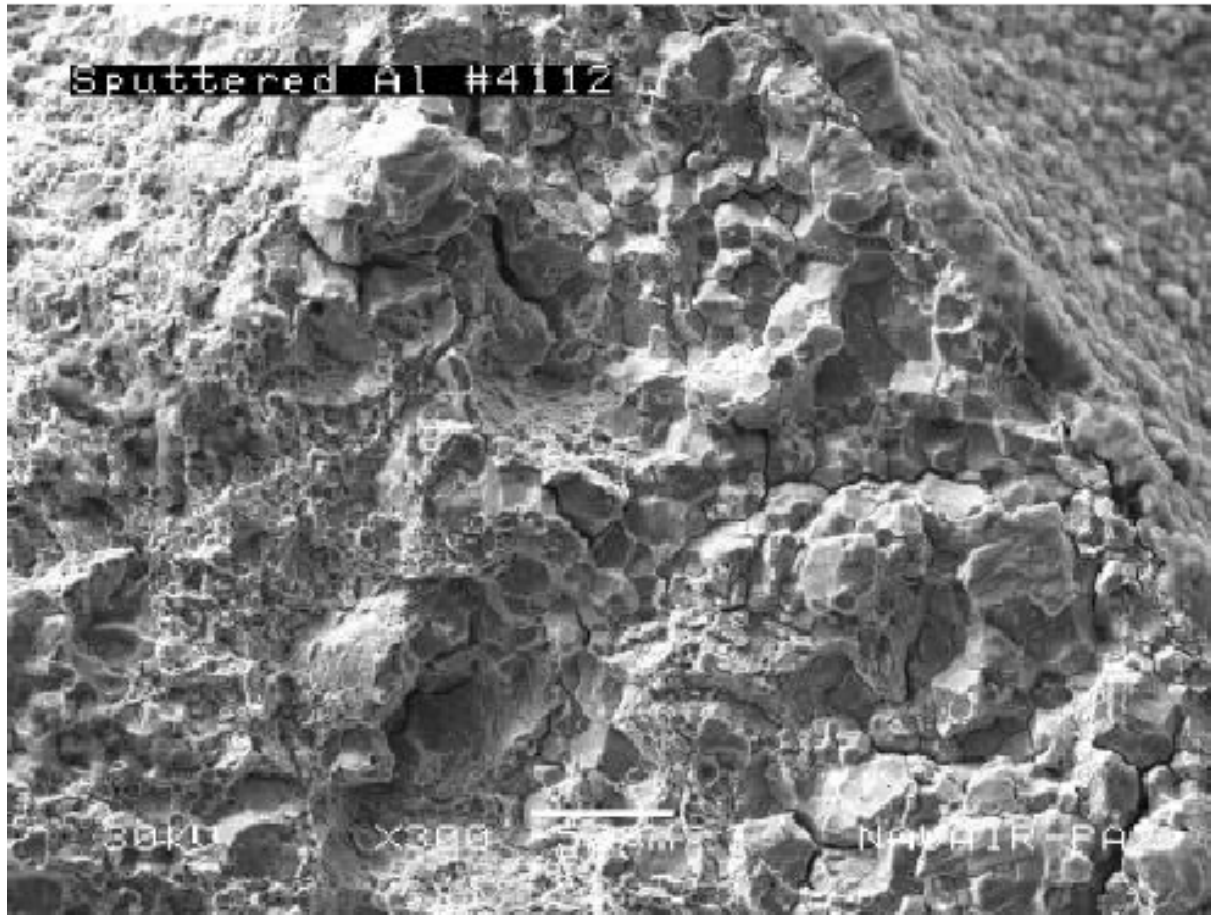
**Close-up of Sputtered Aluminum tested in seawater.**

- Shows intergranular fracture at surface of specimen.

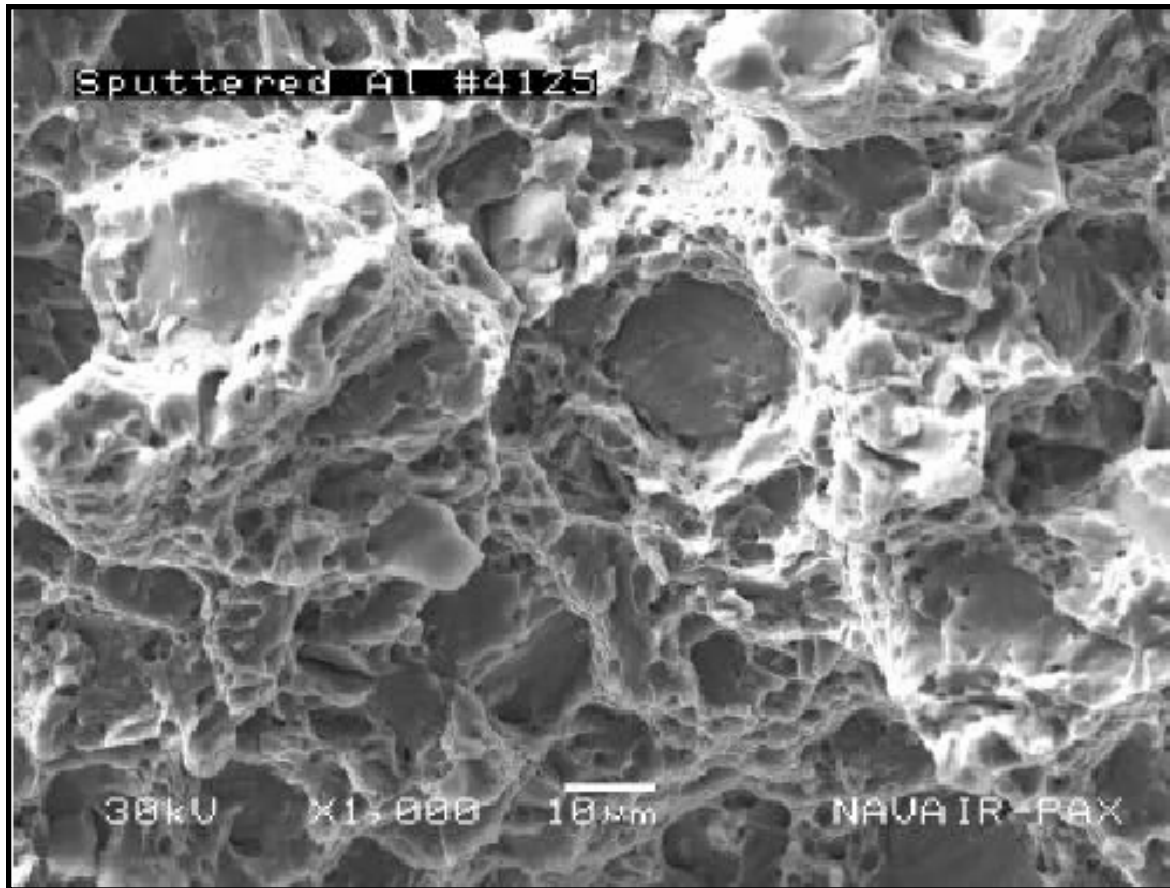
**Close-up of Sputtered Aluminum tested in seawater.**

- Shows overload area with mixed ductile dimples and smooth facets suggestive of brittle fracture.

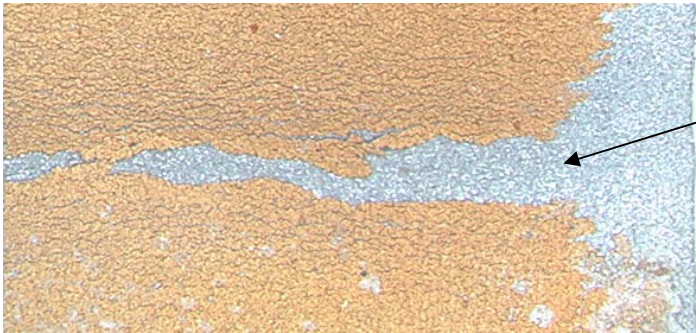
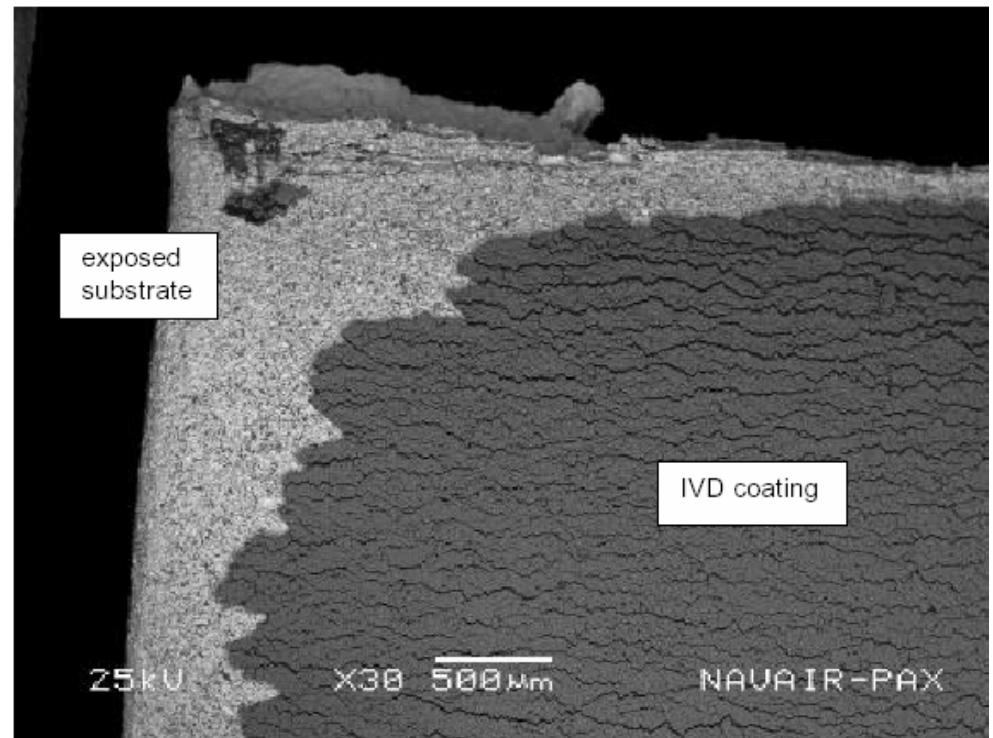
IVD Aluminum coating  
flaked off of panel.

SEM/EDS analysis  
confirm exposed  
substrate.

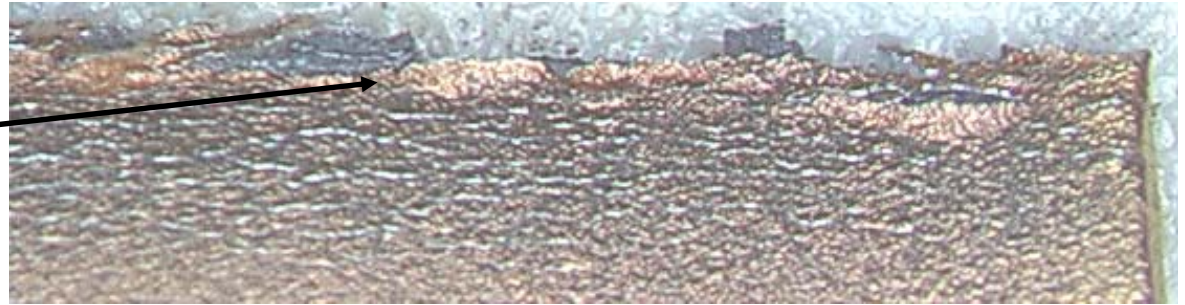
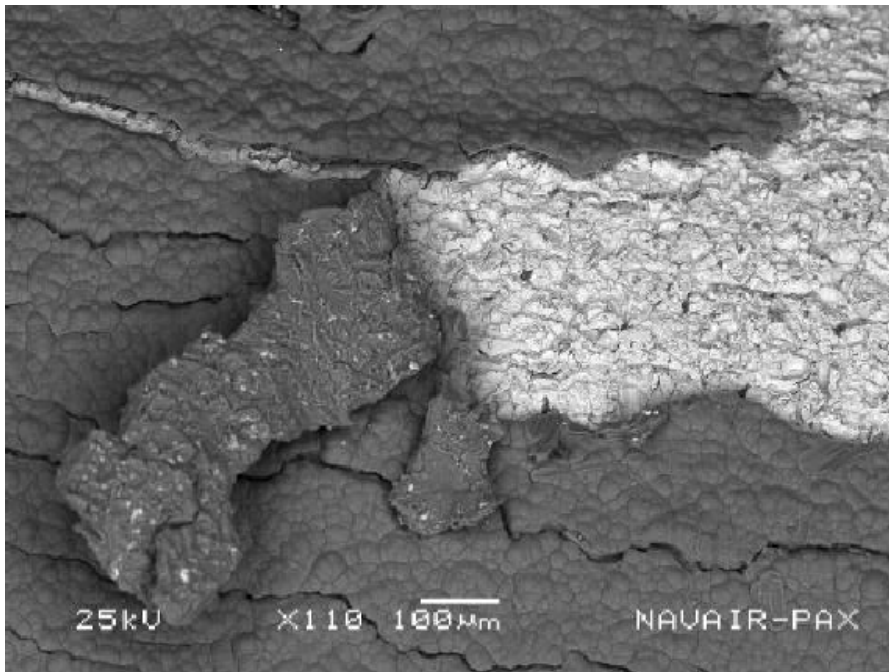
Minor peeling of  
Alumiplate  
coating from  
panel.

Coating peeled back  
gently with razor.  
SEM/EDS analysis  
confirm exposed  
substrate.

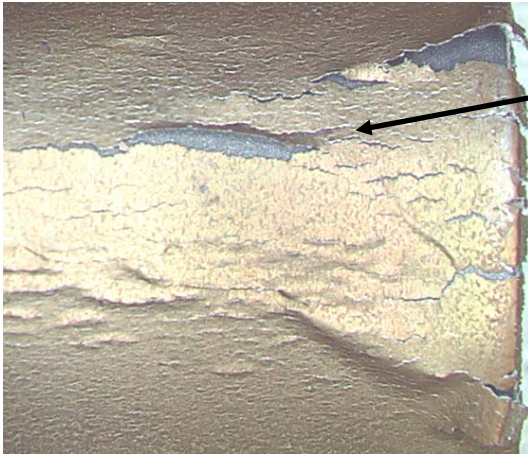
Brush Cd  
coating flaked  
off of panel.

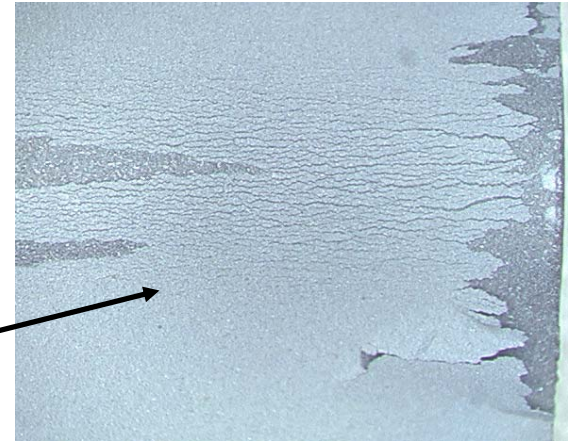
Sermetel 249  
coating flaked  
off of panel.

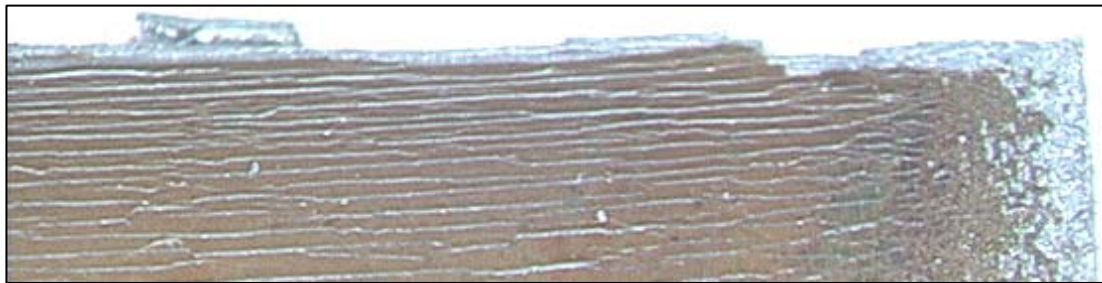
Brush ZnNi coating cracked but did not pop off panel.

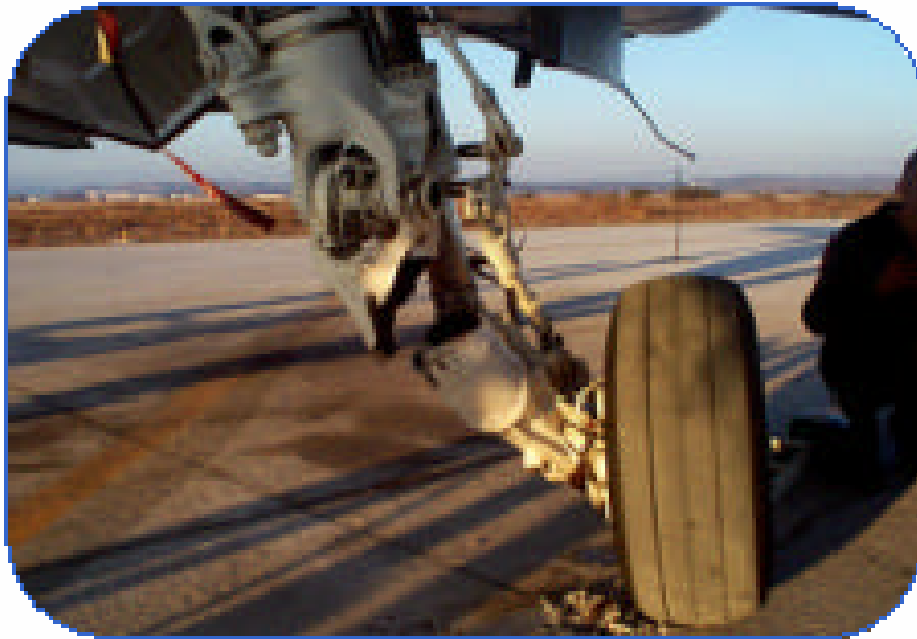
**Landing Gear  
Stress  
Corrosion  
Cracking**
